**TYPE II CONDITION AUDIT REPORT**  
**EGANVILLE AND DISTRICT COMMUNITY ARENA / HALL**  
**178 JANE STREET**  
**EGANVILLE**

September 2013

**J.L. RICHARDS & ASSOCIATES LIMITED**  
Consulting Engineers, Architects & Planners

JLR No. 21981-25

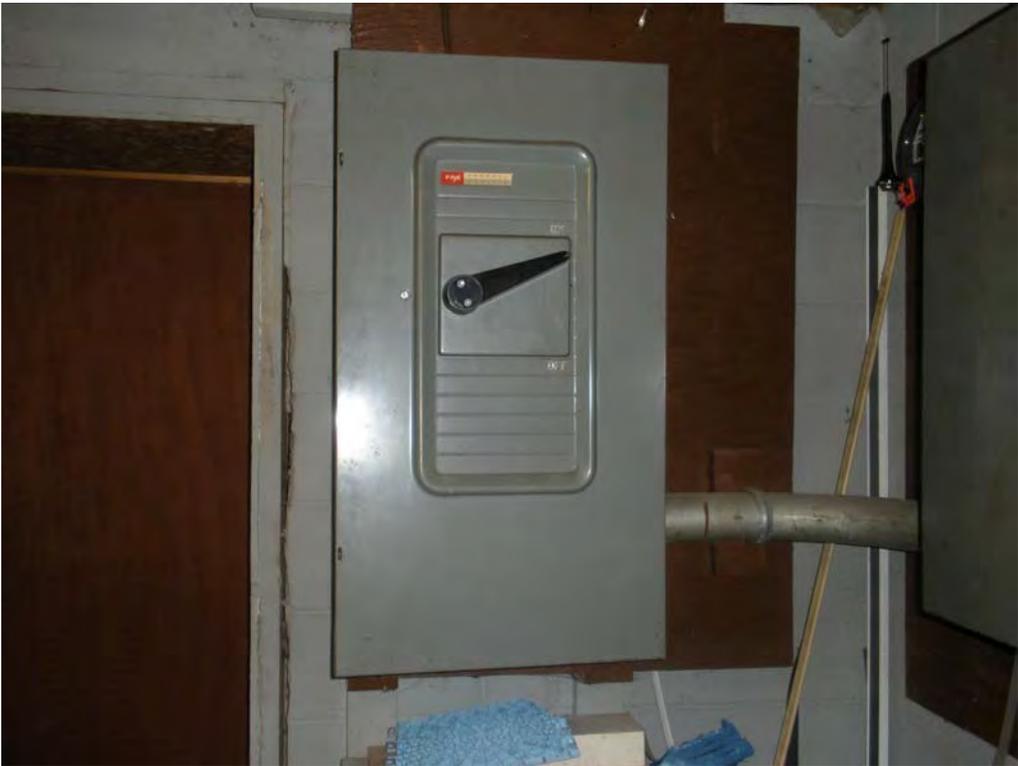
**PHOTOGRAPH NO. E1** – Main Incoming 400 Amp, 600 V, 3 Phase Service Entrance Disconnect Switch.

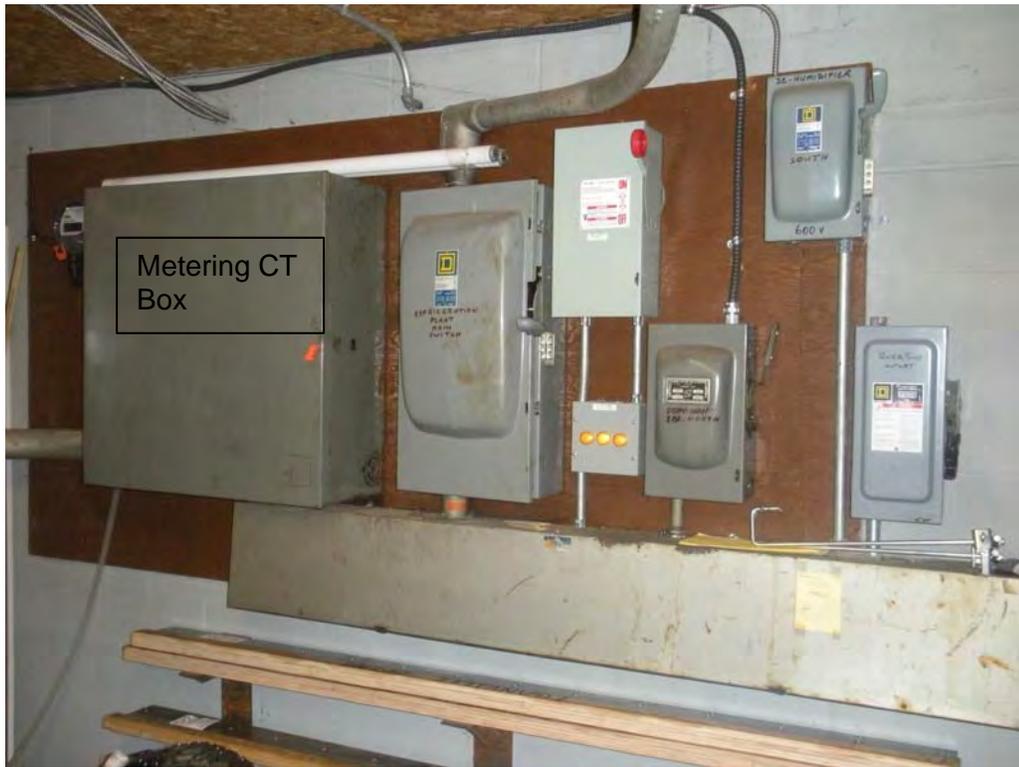
**PHOTOGRAPH NO. E2** – Splitter through 600 V, 3 Phase

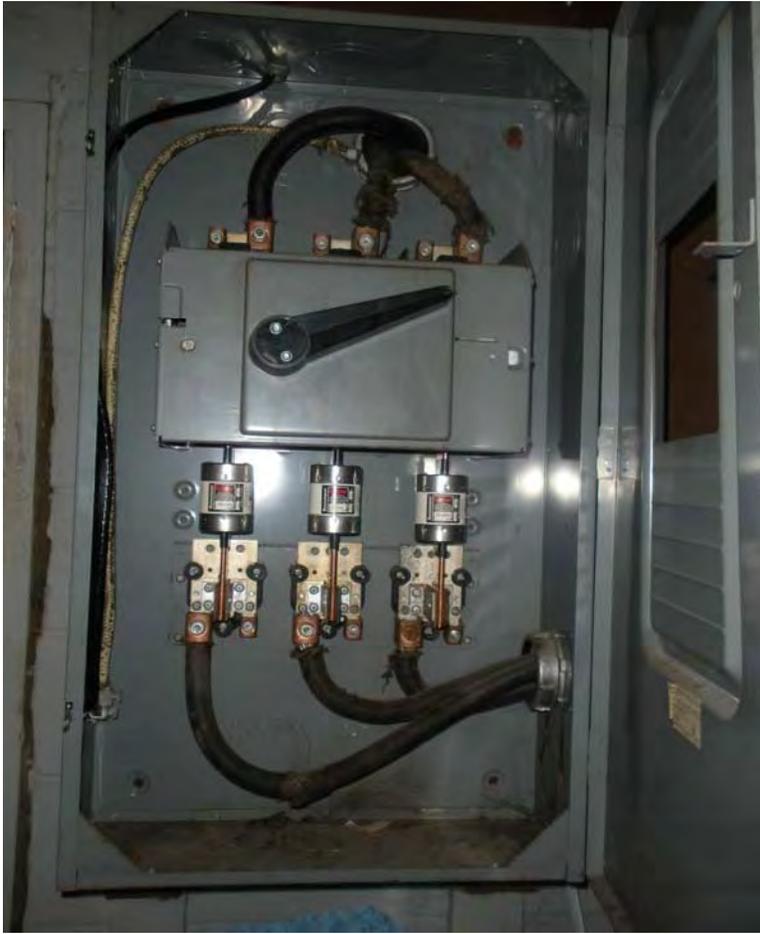
**PHOTOGRAPH NO. E3 –**  
Inside the 400 Amp, 600 V  
Disconnect Switch.

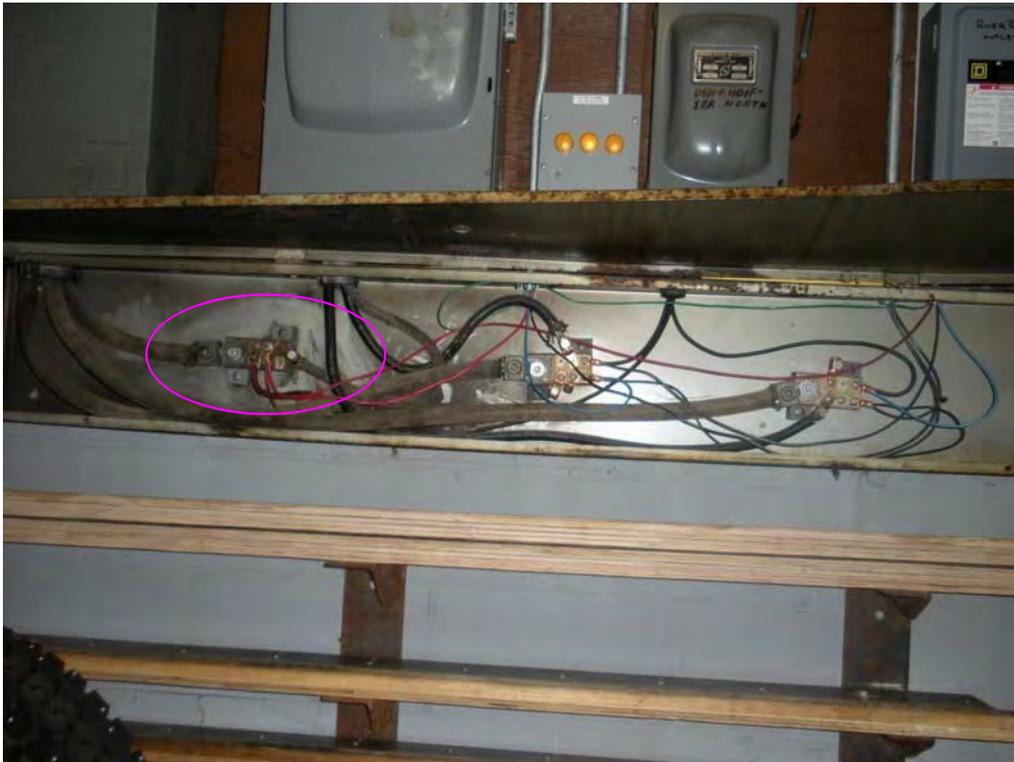
**PHOTOGRAPH NO. E4** – Terminal Block Appears to Have Overheated Compared to Other Two Terminal Blocks

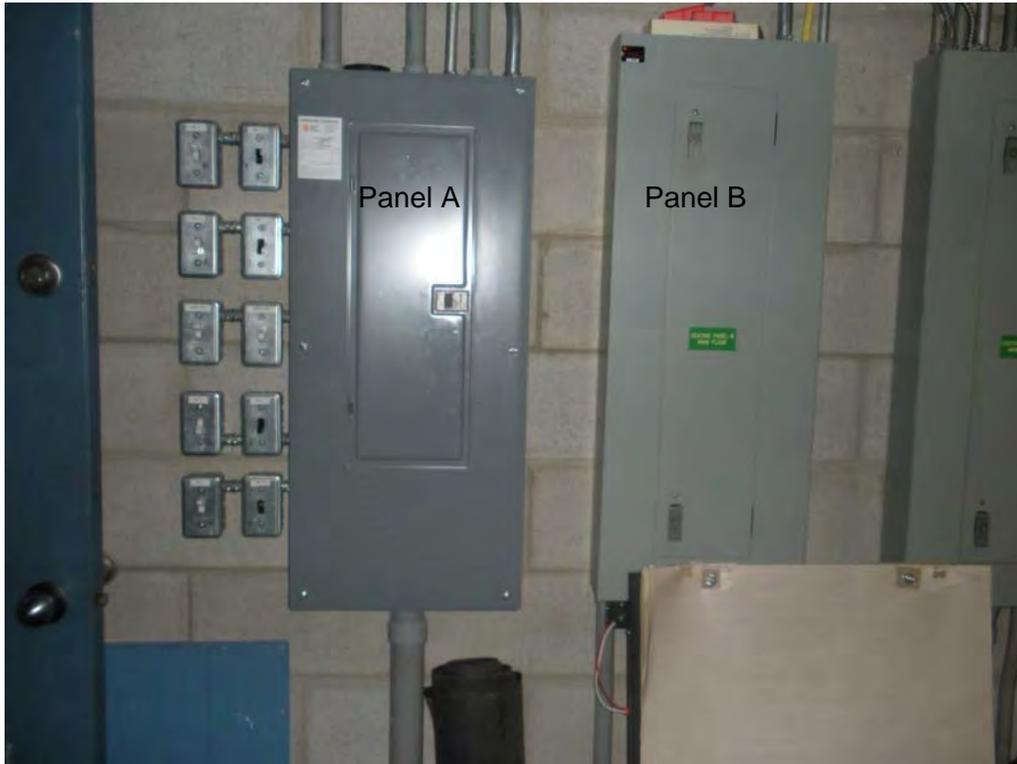
**PHOTOGRAPH NO. E5** – Panel B is Typical for Panels C, D and E.

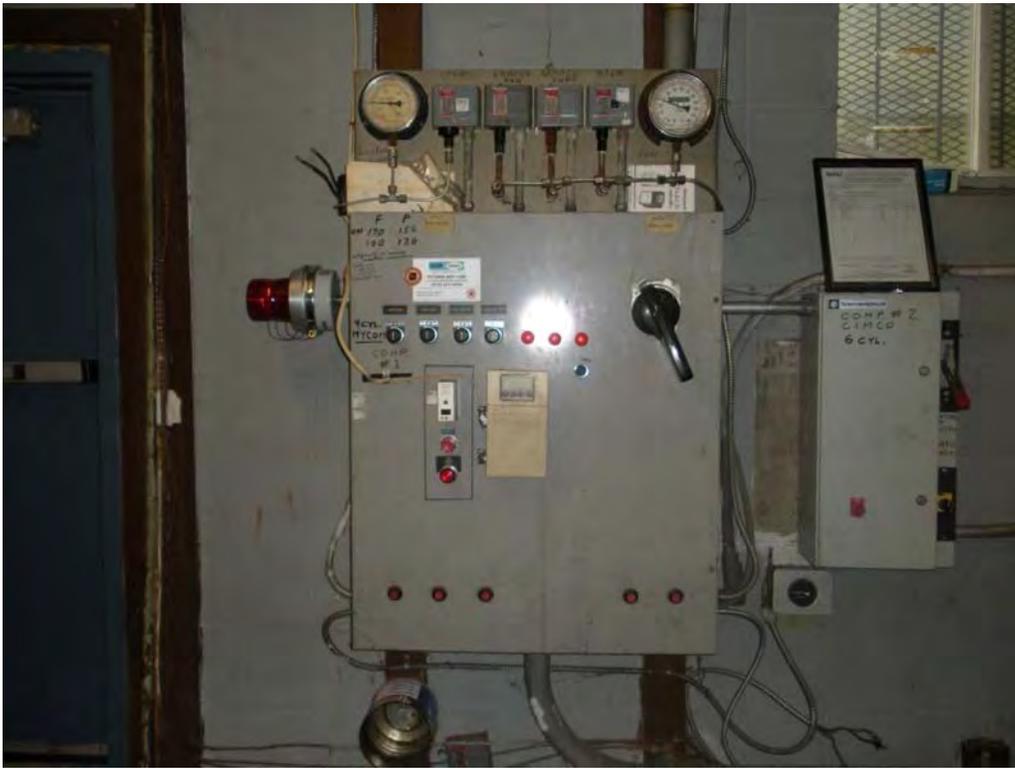
**PHOTOGRAPH NO. E6** – CIMCO Refrigeration Control Panel.

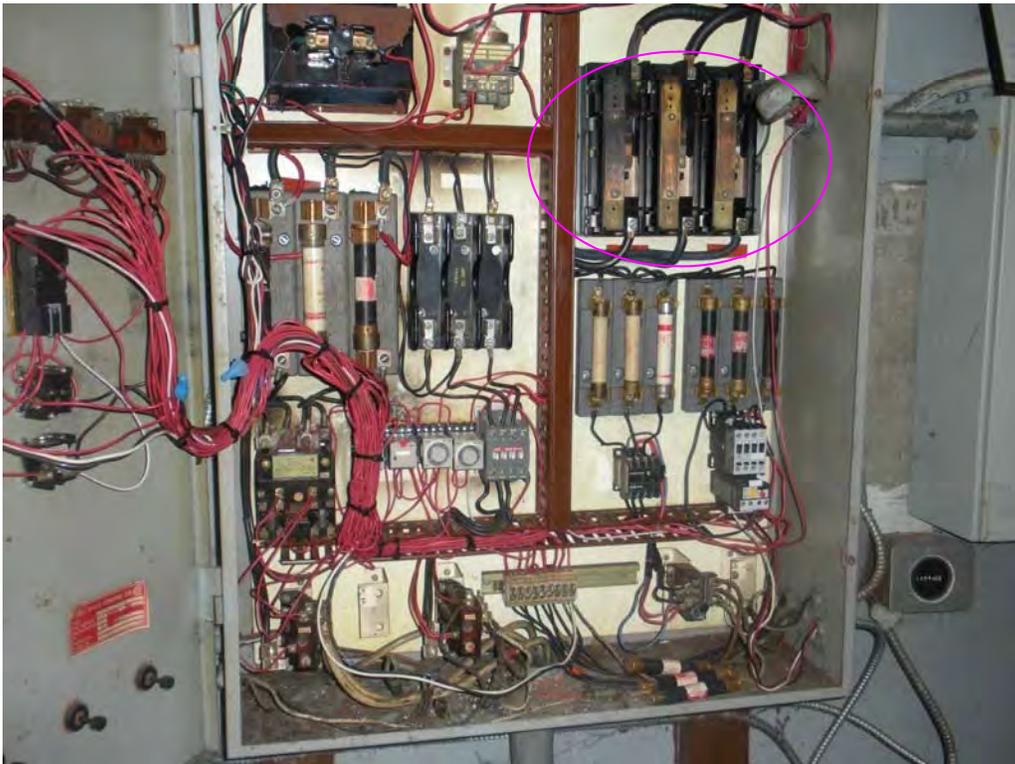
**PHOTOGRAPH NO. E7** – The Terminals and Conductions Show  
Signs of Overheating.
