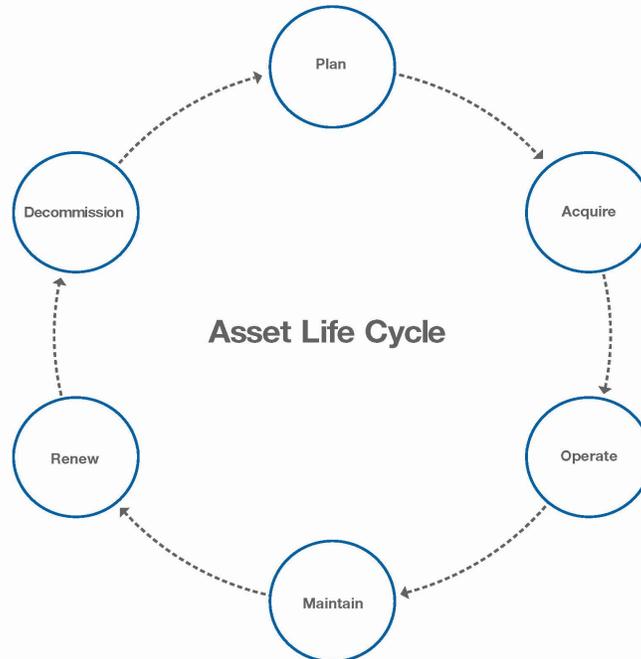
Asset management is a structured program to minimize the life-cycle costs of asset ownership while maintaining required service levels and sustaining the infrastructure. The principle of *Life-Cycle Costing* is expressed in financial terms to include the total cost of an asset throughout its entire life. This should encompass all the activities associated with acquisition, installation, operation, maintenance, periodic refurbishments and disposal of that asset as shown in Exhibit 1 below.

Exhibit 1 – Typical Asset Life Cycle

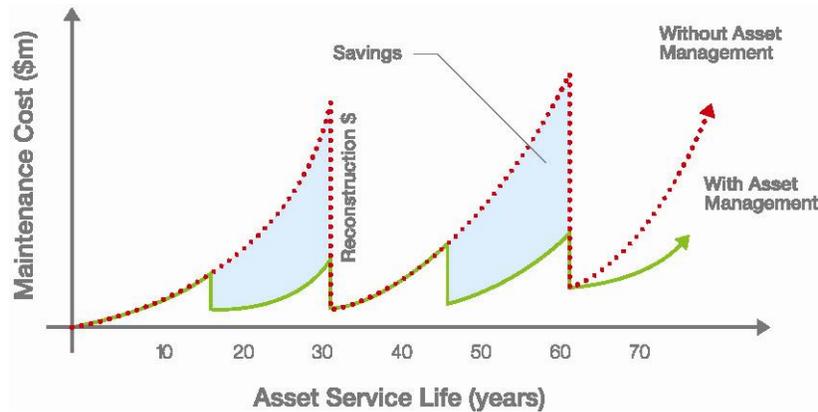
Exhibit 2 – Asset Management Extends Service Life and Reduces Maintenance Costs

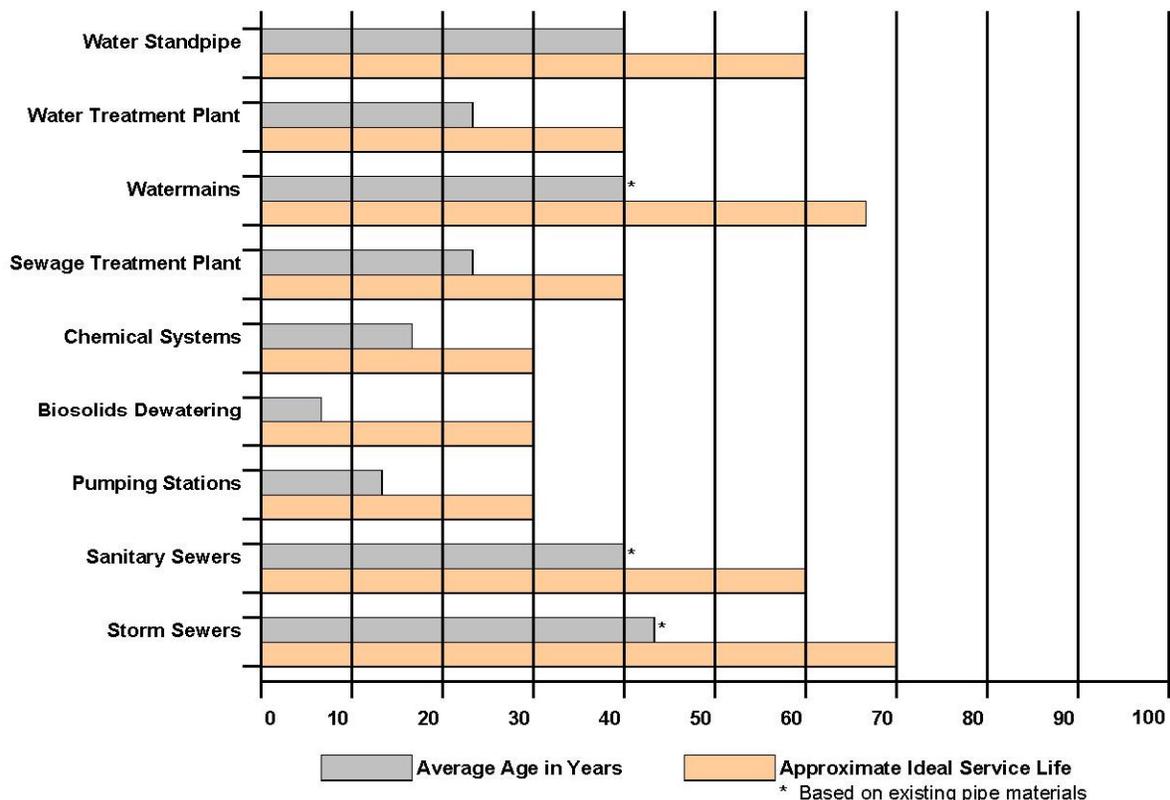
Exhibit 3 below illustrates the Township's water and sewer infrastructure Average Age versus Ideal Service Life.

Exhibit 3 – Average Age and Ideal Service Life

Currently, much of the Township's infrastructure is approximately halfway through its ideal service life. As these assets age, *preventative* maintenance will extend their useful life. Annual maintenance costs will, however, gradually increase over time as these assets approach their end-of-life cycle. The Township must be proactive in monitoring these annual maintenance costs so that staff and Council can make informed decisions with respect to the timing of various inevitable capital projects for rehabilitation or replacement of problem infrastructure.
