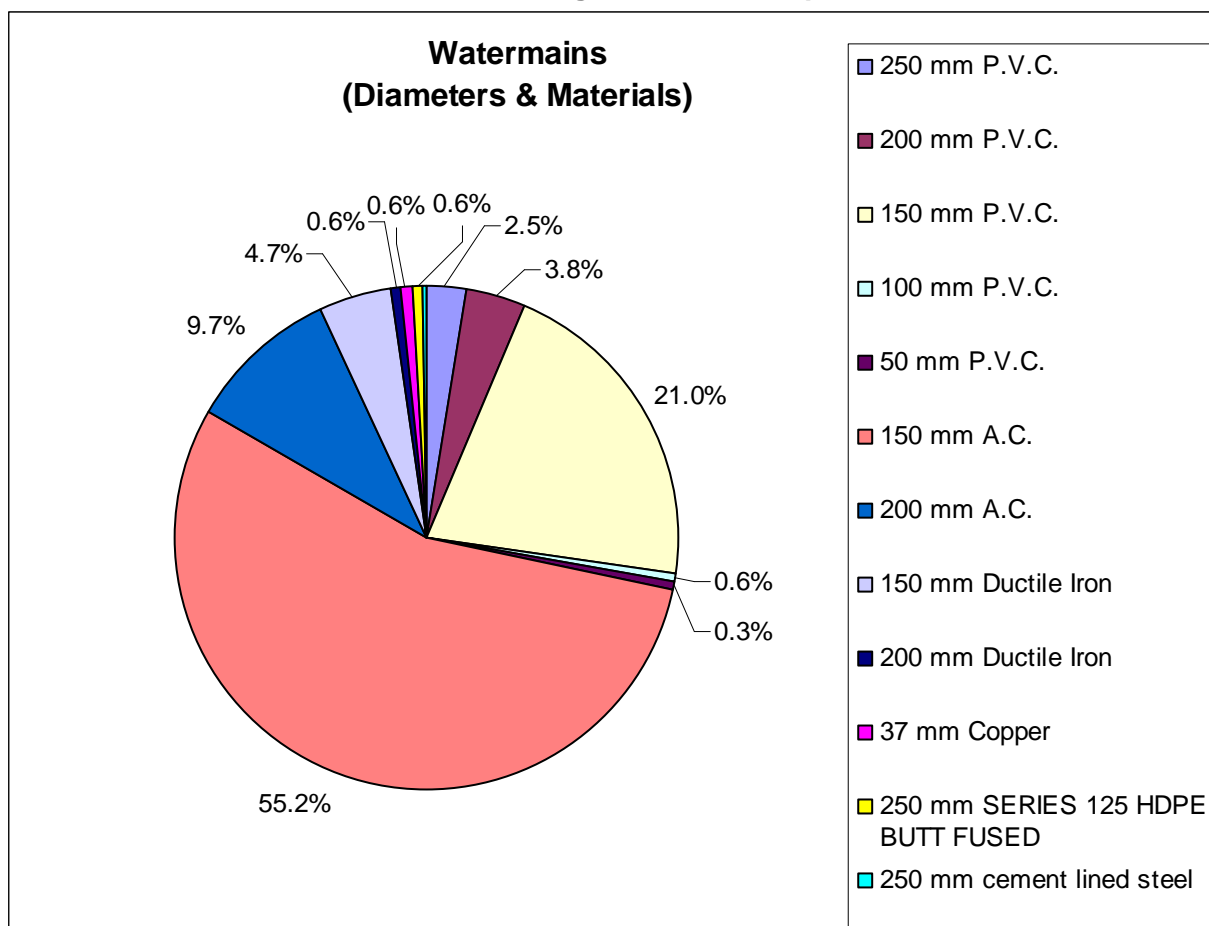
**Exhibit 14 – Percentage of Installed Pipe Material**

Asbestos Concrete. This pipe material has an Ideal Service Life of 70 years; however, asbestos concrete pipes have been known to fail earlier as compared to other industry standard materials such as PVC. Most of these asbestos concrete watermains are past the mid-point of their Ideal Service Life and planning for replacement or rehabilitation of these pipes should be a Township priority. The replacement value of Asbestos Concrete watermains in Poor or Fair condition is approximately \$2,352,000.
